## JAMES CLAYTON LECTURE

# Problems Encountered by the Royal Electrical and Mechanical Engineers in the Field

By Major-General Sir E. Bertram Rowcroft, K.B.E., C.B., M.I.Mech.E.\*

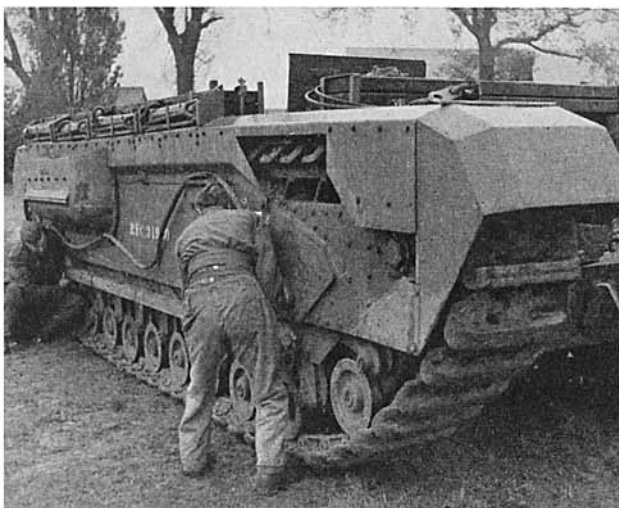
Fig. 13. Churchill Armoured Recovery Vehicle ("A.R.V."), Mark I

By mid-1942 a prototype Churchill A.R.V. (armoured recovery vehicle) had been produced (Fig. 13, Plate 2). In this machine the turret was removed and a flat hinged lid was substituted. A jib, drawbars, flame-cutting equipment, and a certain amount of fitters’ gear was carried, together with “spuds”, holdfasts, tow ropes, and snatch blocks. There was, however, no winch and no heavy-lift jib—that provided being capable of a 3-ton lift only. The reasons for these omissions were the lack of manufacturing capacity and also the lack of time.

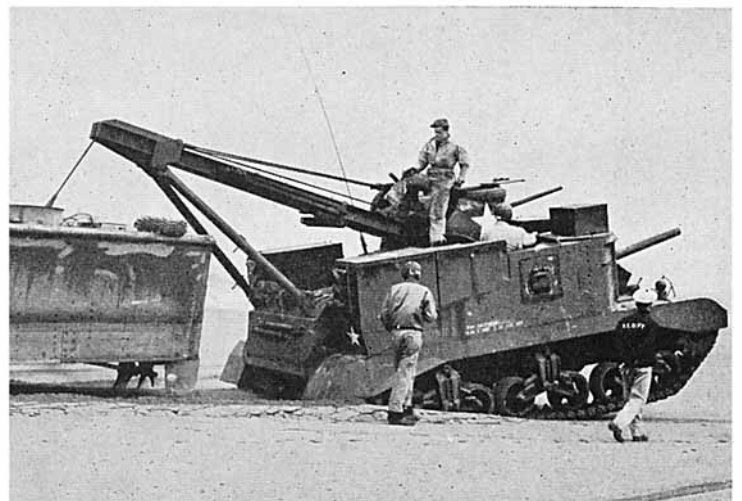
Fig. 14. American "T.2" Recovery Tank

A little later, in Italy, the British Army were fortunate to get a few American “T.2”s, recovery tanks on Grant hulls with a mechanically operated winch and a high-lift jib (Fig. 14, Plate 2). These proved invaluable for recovery work in mountainous terrain where it was frequently impossible to get a straight pull and a clear run for the recovery vehicle.

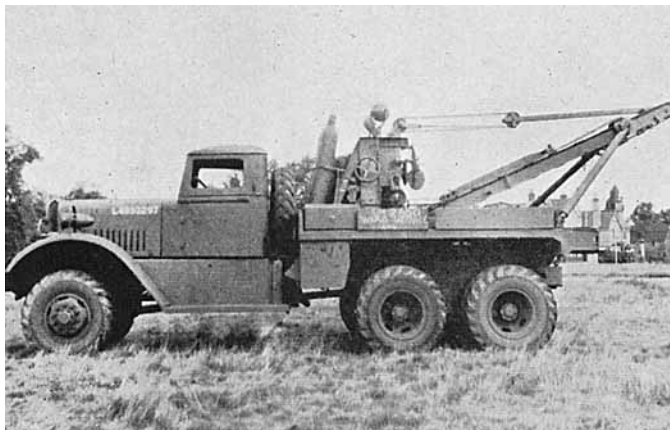
Fig. 15. Another Type of Recovery Vehicle

The wheeled recovery vehicle (Fig. 15, Plate 3) was a very fine six-wheeled four-wheel-drive type, resembling existing makes then in use, but with a larger-capacity engine, a more powerful winch, and a greater capacity luffing jib-crane.

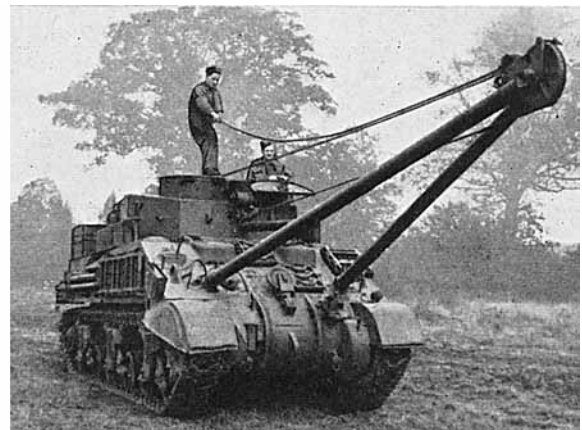
Fig. 17. Sherman A.R.V., Mark II

Meanwhile, we had been pushing on with the idea of the jibbed and winched A.R.V. and, eventually, after many vicissitudes and an intensive search for production capacity in the United Kingdom, we produced, for issue in 1944, the A.R.V. Mark II in its Churchill form (Fig. 16, Plate 3) and in its Sherman form (Fig. 17, Plate 3).

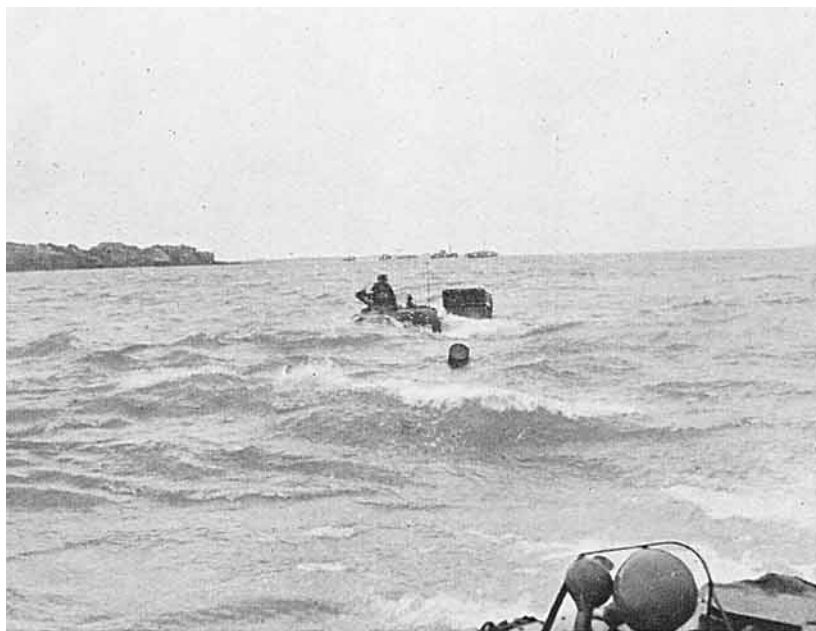
Fig. 20. A.F.V. Wading with Waterproofing Equipment

The removal of the external chutes, which were a hindrance to the tank's tactical role once ashore, was carried out by automatic means and fabrics, enveloping guns, instruments, air inlet louvres and turret rings, were blown off by explosive operated by the driver. Figs. 20–23, Plate 4, show the process.

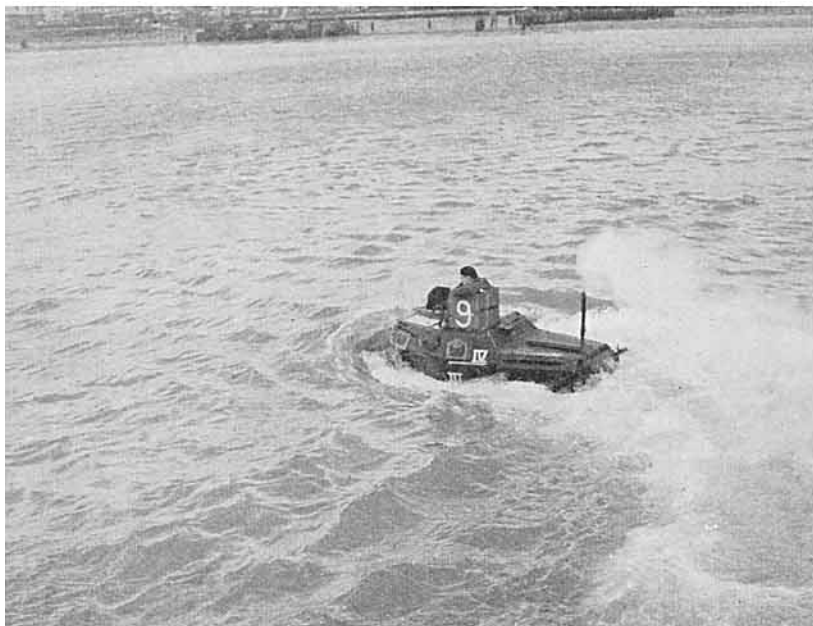
Fig. 24. Scout Car Wading

Fig. 24, Plate 5, shows a scout car wading, and Figs. 25 and 26, Plate 5, a carrier. The latter had its sides artificially increased in height by panels secured to brackets welded on to the original structure. Fig. 27, Plate 5, shows an armoured car wading.

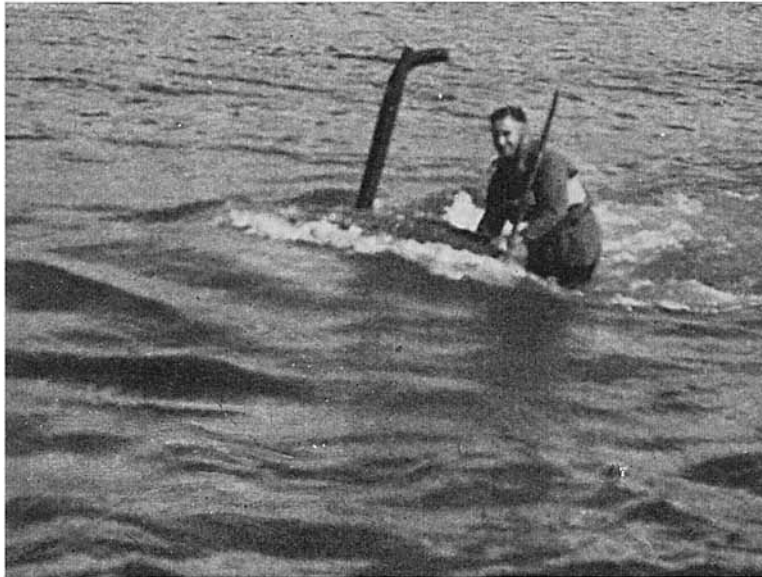
Fig. 30. "Jeep" wading in 5 feet of Water

The next few illustrations show the results achieved by sound waterproofing. Fig. 30, Plate 7, shows a “Jeep” wading in 5 feet of water, and Fig. 31, Plate 7, shows a “10-tonner” entering the water from the landing craft (“L.C.T.”) and gives an idea of the degree of immersion at this stage.

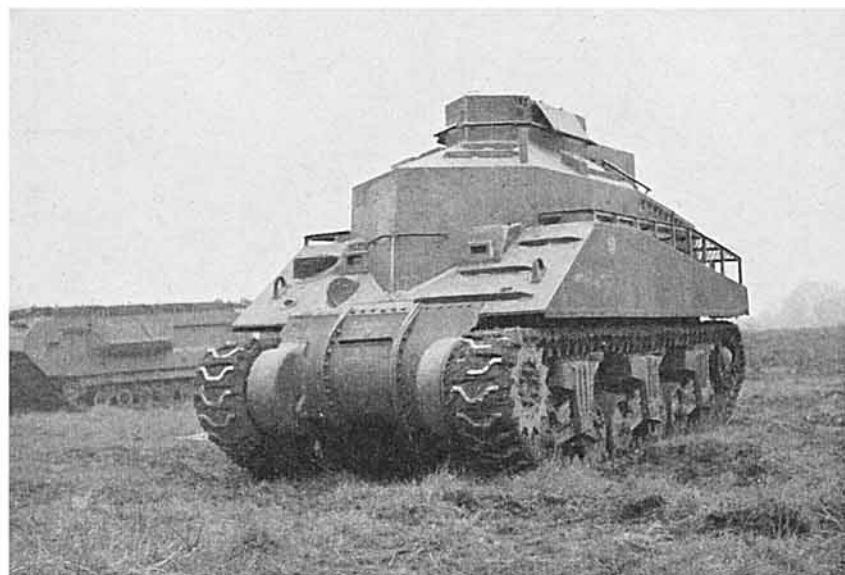
Fig. 35. Beach Armoured Recovery Vehicle ("B.A.R.V.")

To accomplish this we used, for the under-water part of the work, Beach Armoured Recovery Vehicles (B.A.R.V.’s) and armoured “D.8” tractors (Figs. 35 and 36, Plate 8).

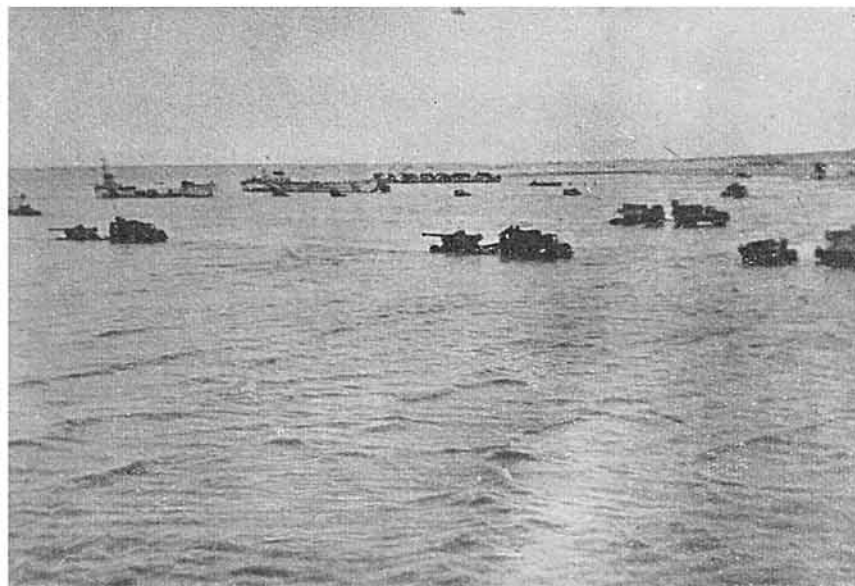
Fig. 37. The Army Wades Ashore : Normandy, 6th June 1944

Fig. 37, Plate 8, shows the passage in progress. The vehicles were a great success, and even achieved a tactical surprise, as on “D-Day” the first “L.C.T.” landing craft to touch down was unfortunately the wrong one. It was filled with R.E. vehicles and a B.A.R.V., which took the water first and struck terror into the local opposition. The German *communiqué* spoke of the “new British Goliath tank” being the first to land. This was it!
